Manhole Inspection Summary

Manhole # S41SS_022MH

Insp Date: **2/19/07 11:44 AM**

Location Address: **2559 GARRETT AVE**

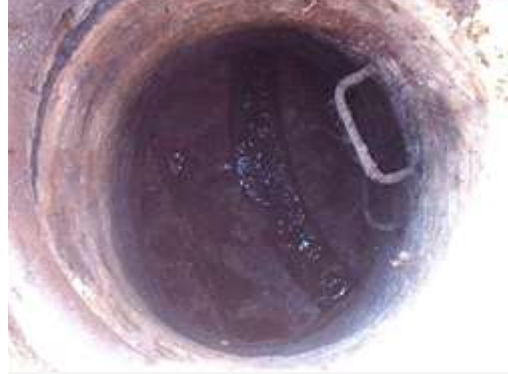
Top View

Infiltration: ☐ None ☐ Joint ☐ Cracks ☐ Mortar ☐ Roots ☒ **Wall**

Surcharge ☒ **Evidence Of Surcharge** Depth: **1.5** (ft.) ☐ Active Surcharge Present

Barrel infiltration. Evidence of surcharge - Bench debris.

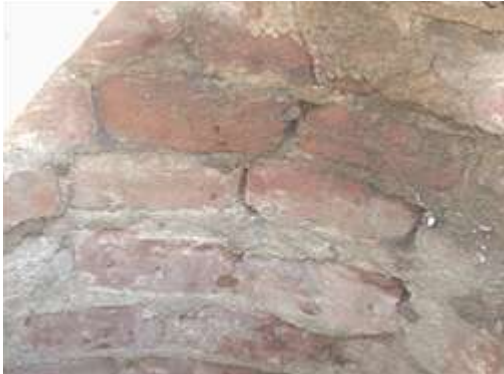
Defect

Condition: ☐ Sound ☐ Cracked ☐ Root Intrusion ☐ Loose Brick ☒ **Deteriorated**

Infiltration: ☐ None ☐ Joint ☐ Cracks ☒ **Mortar** ☐ Roots ☒ **Wall**

Corbel deterioration and infiltration.

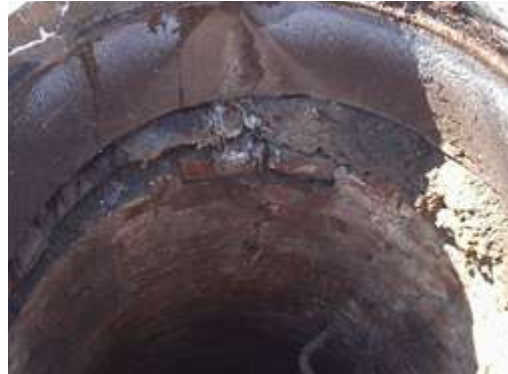
Defect

Frame Offset: **0** (in.) Condition: ☐ Sound ☐ Cracked ☒ **Leaks**

Condition: ☐ Sound ☐ Cracked ☐ Root Intrusion ☐ Loose Brick ☒ **Deteriorated**

Infiltration: ☐ None ☒ **Joint** ☐ Cracks ☐ Mortar ☐ Roots ☒ **Wall**

Frame leaks. Frame offset. Adjustment deterioration and infiltration.

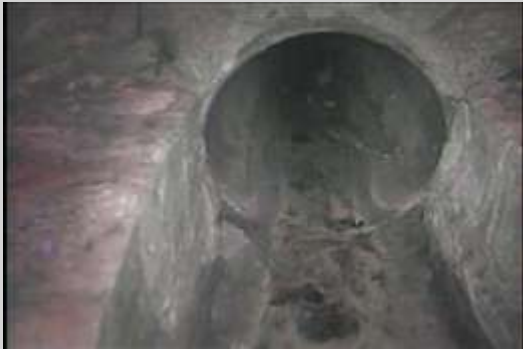
8 in. Circular Gravity Sewer Pipe Out @ 12 O'Clock

Infiltration: **Evidence** Pipe Seal Cond: **Unknown**
